Subject: Phase III Bond Release, PacifiCorp, Deer Creek Mine, Left Fork of Rilda Canyon, C/015/0018, Task #5775

2.33 acres in the Left Fork of Rilda Canyon
Phase III Bond Release
PacifiCorp
Deer Creek Mine
C/015/0018
Emery County, Utah

Inspection Report

This is a final (phase III) bond release inspection on 2.33 acres in the left fork of Rilda Canyon. This site was mostly reclaimed by PacifiCorp (the permittee) but after a large fire occurred in the area (Trail Mountain Fire), the Forest Service requested that this area be returned to them so that they could construct sediment control features in an effort to prevent damage to the Emery County Water Users Springs in the Rilda drainage. Others participating in the inspection but not listed below include: Rebecca Anderson and Andrea Johnson with the BLM, TJ Cook with the DWR, Jeff Salow with the USFS, and Ray Peterson with Emery County.

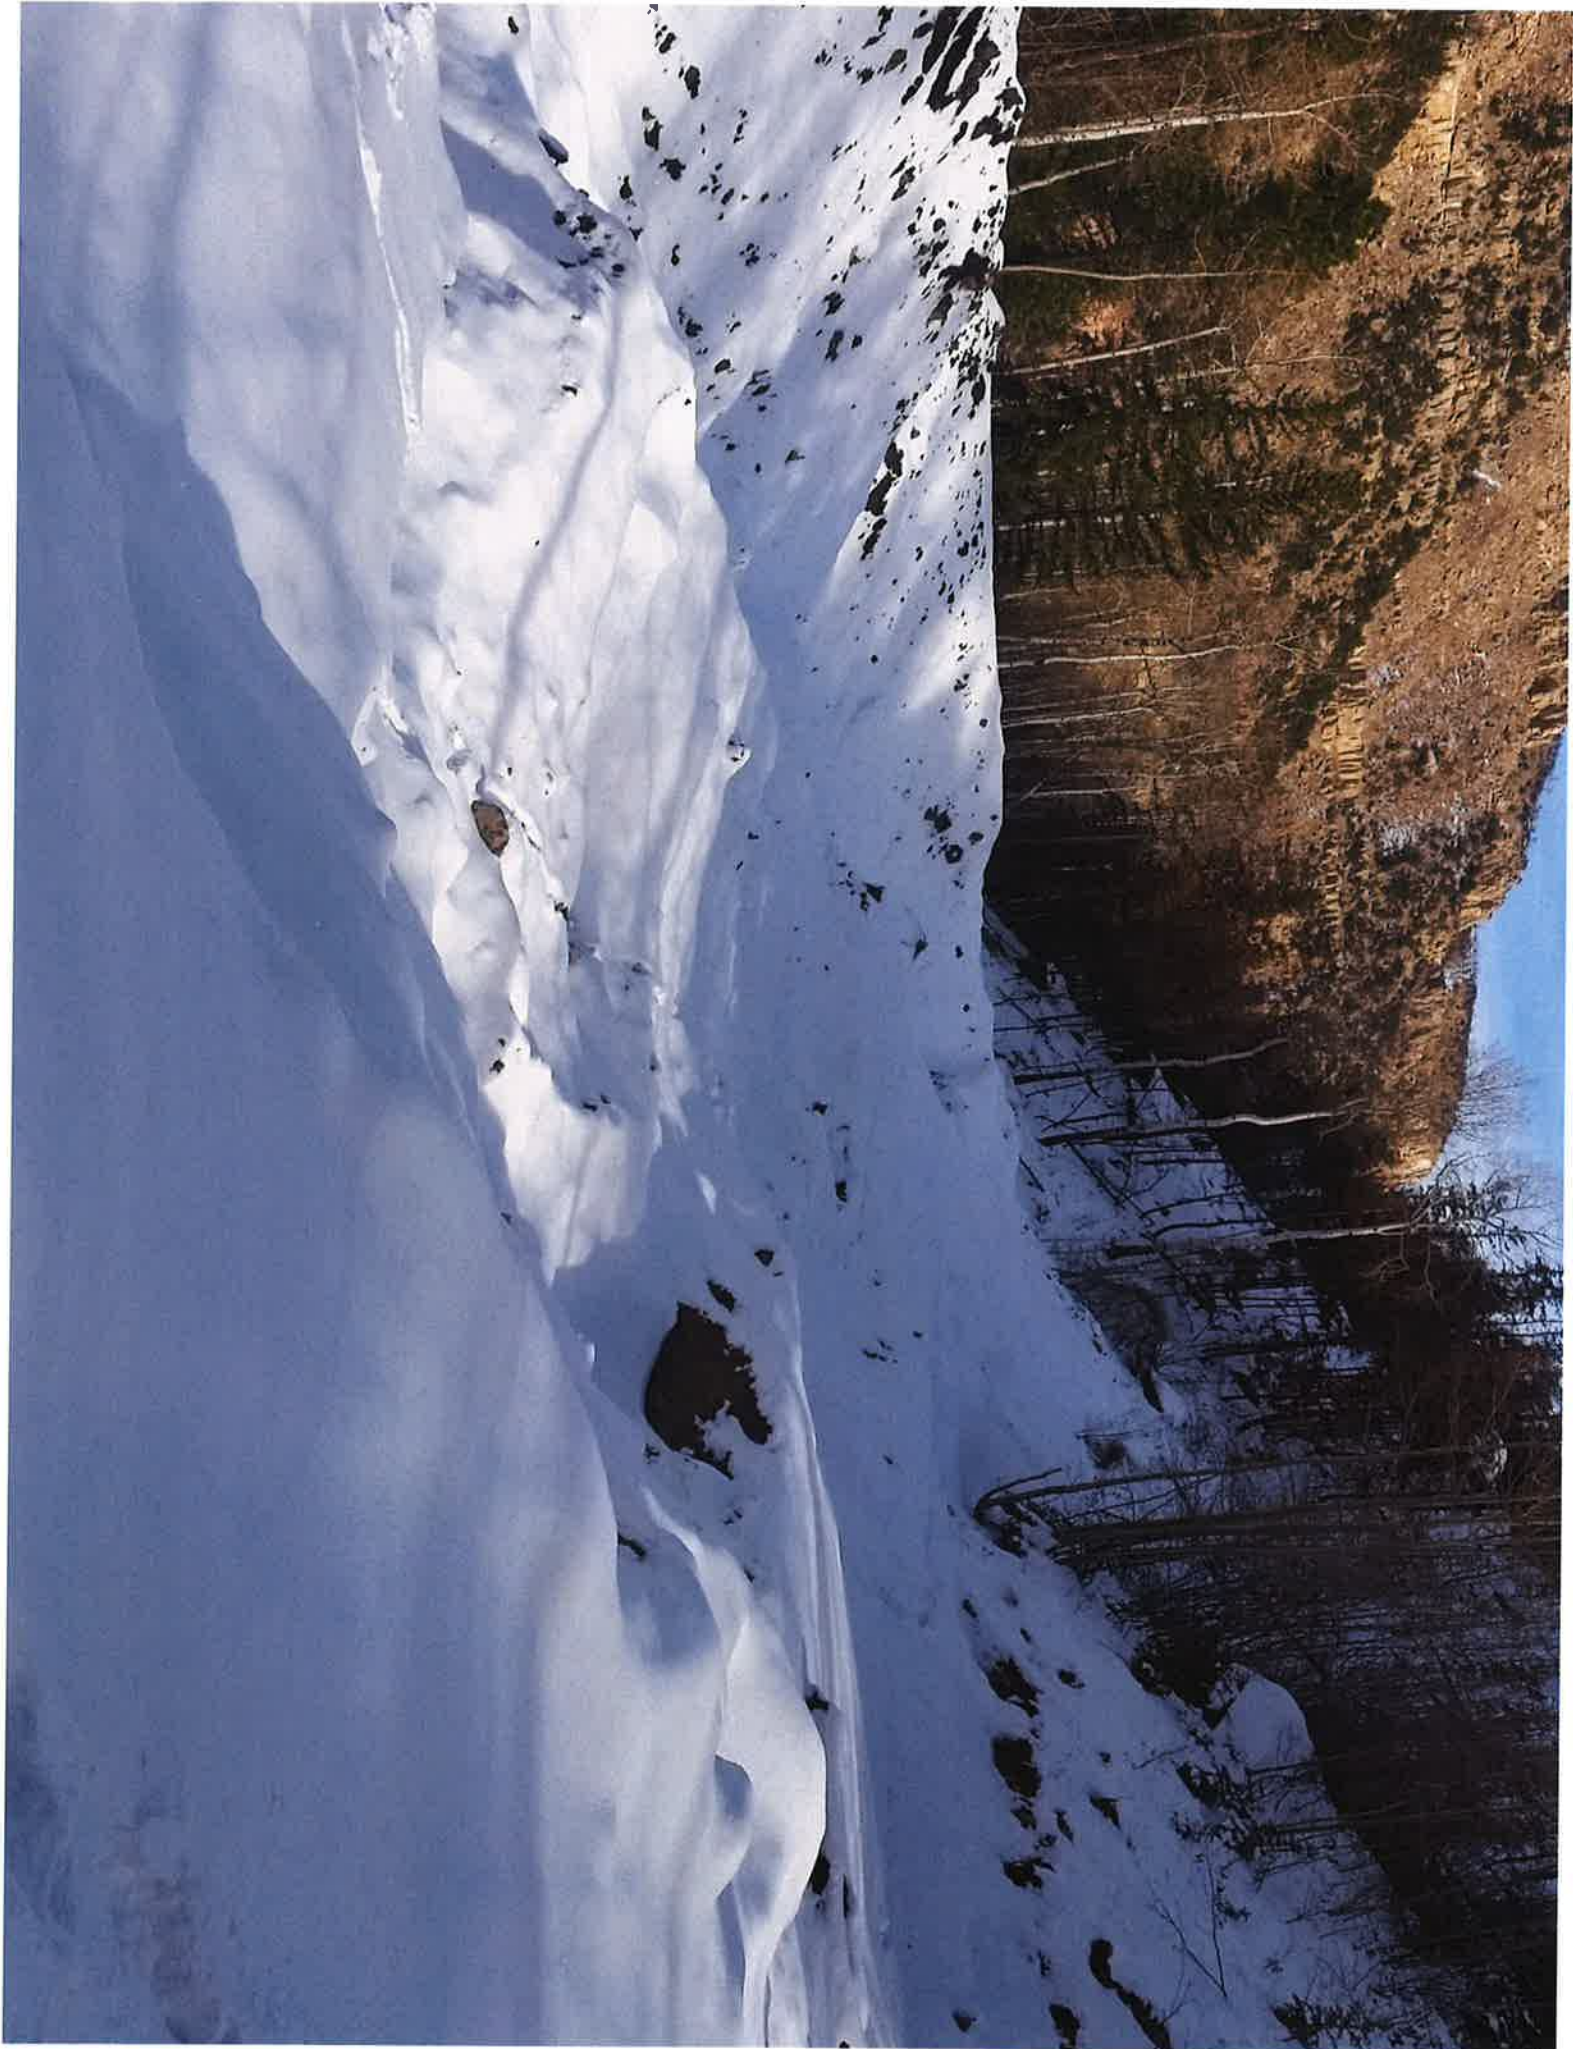
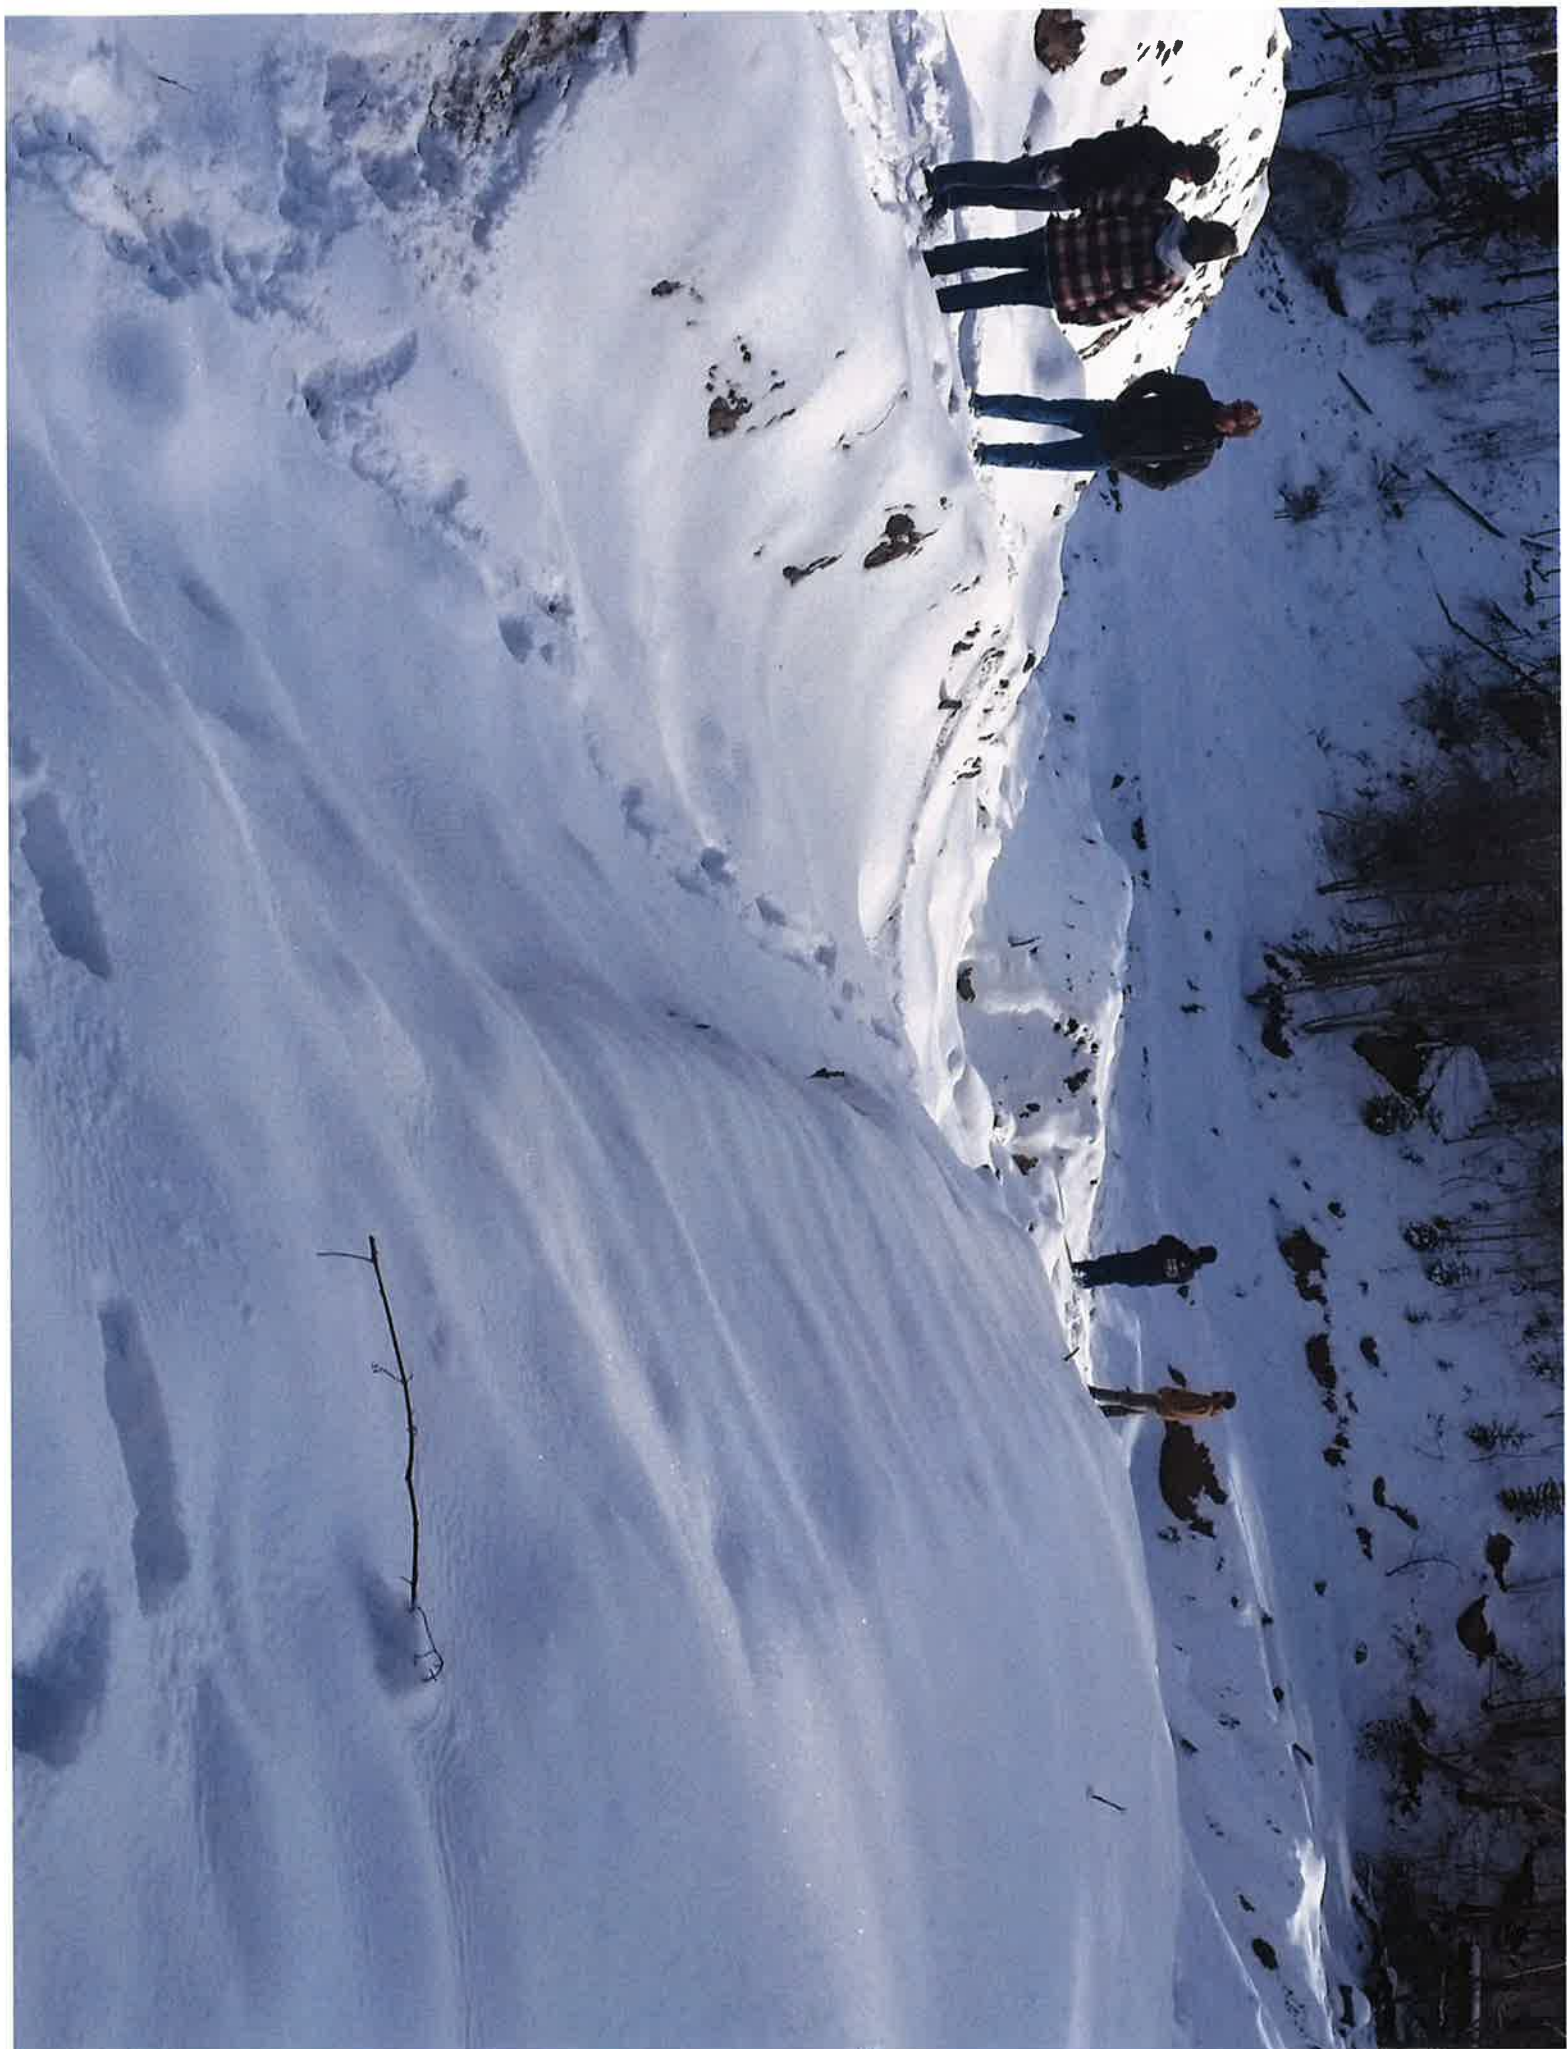
The 2.33 acre area has been turned over the USFS so that they could construct a debris basin for the purpose of catching sediment that is expected from the recent forest fire. The entire area is developed for sediment control.

The entire 2.33 acre area was evaluated. The Forest Service had constructed a debris basin which had functioned to some degree. The basin had been partially cleaned out and additional berms constructed in an attempt to capture sediment during future storms. There appeared to be two impoundments (catchment basins) on the site, which probably could have been better designed, but they are the responsibility of the Forest Service.

Some debris had entered the site from the South side drainage. Much of it had been cleaned from the basin to provide additional capacity.
